METRIC INFORMATION FROM UNCALIBRATED SINGLE IMAGES

George E. Karras¹, Elli Petsa²

KEY WORDS: lines, camera calibration, camera orientation, object reconstruction

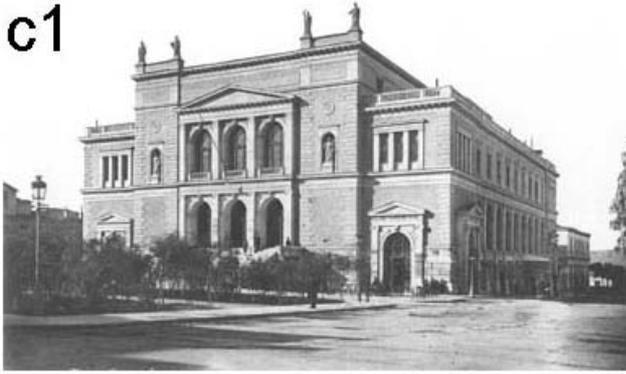
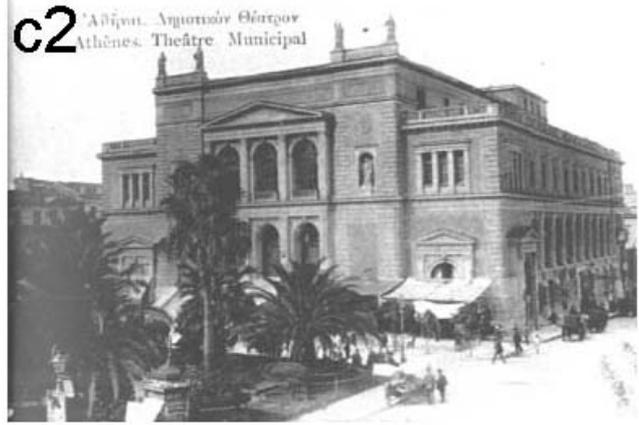
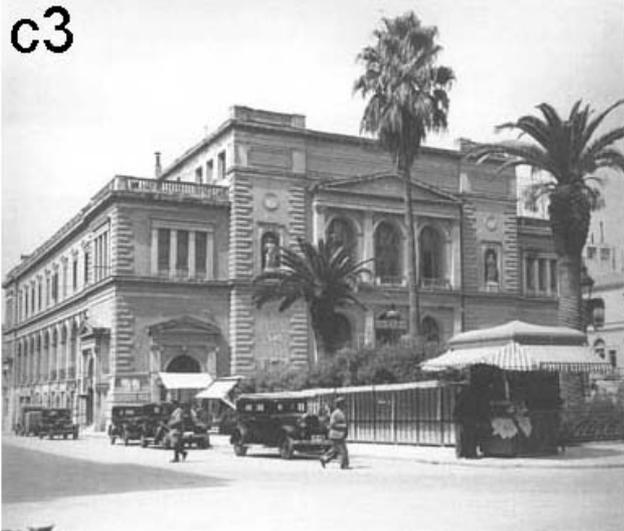
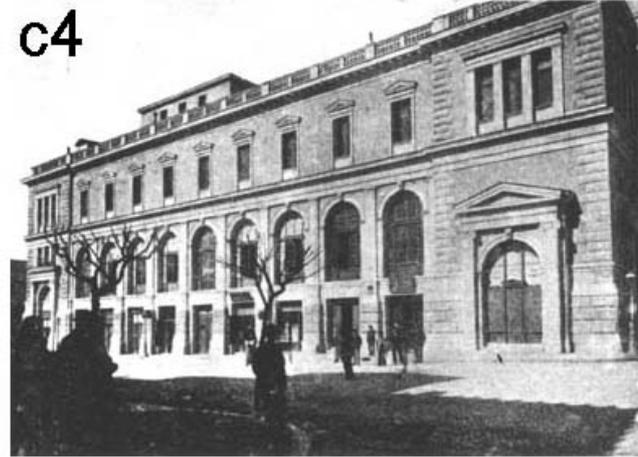
Figure 2. The four old images of the Athens Municipal Theatre.

The four images used have been taken at different time periods (c3 just before demolition) and are seen in Fig. 2. Three of these show the front and include extremely perspective views of the side; the fourth photograph shows the side and allows to 'guess', rather than establish, just a few short lines in the third dimension. The results from this data are found in following Table 3. For scaling, a horizontal dimension of 30 m has been given to the central front part of the building, to which all measures refer.

As seen in the above Table, no scale differences are detected in height. The widths of the two smaller blocks are also consistent (maximal difference 1.2%). The difference between the left and right widths, however, remains unclear since this dimension could not be measured on the third image due to the palm tree. Regarding depth estimation, the small relief on either side of the central block also appears as consistent. Finally, the total depth of the building is estimated with a maximal difference of 3%. E

ven the view c4 from the side (the results of which were simply scaled through a height transferred from the other images) gives a close estimation.

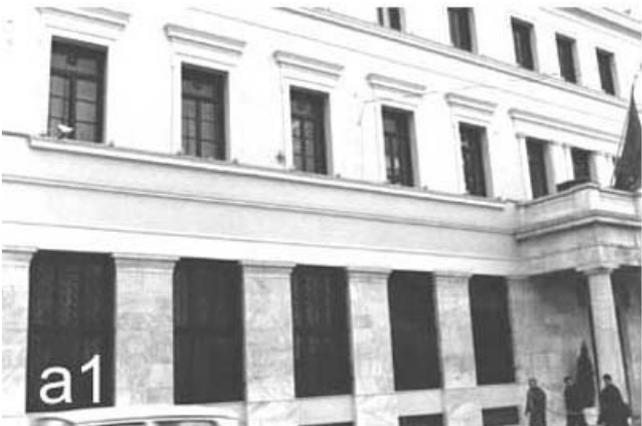
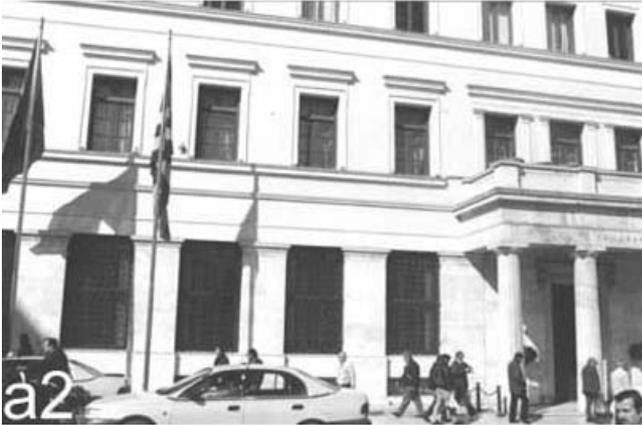
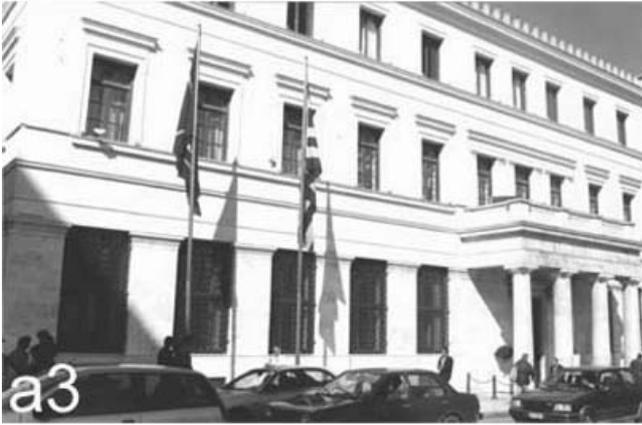
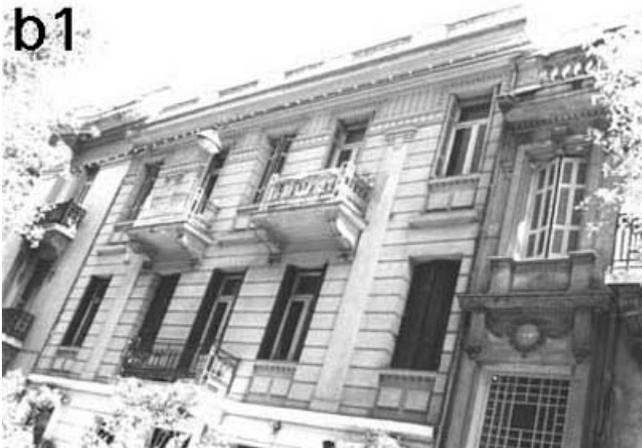
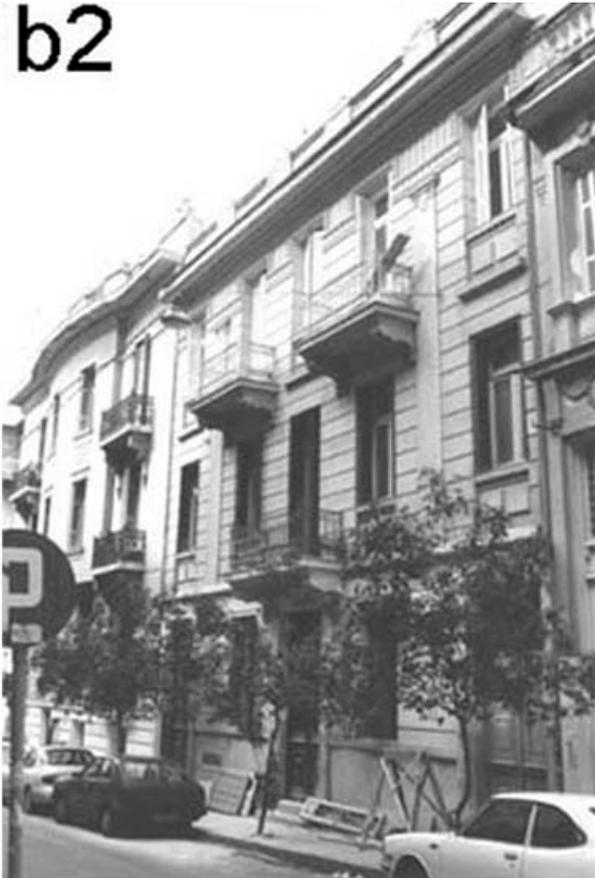
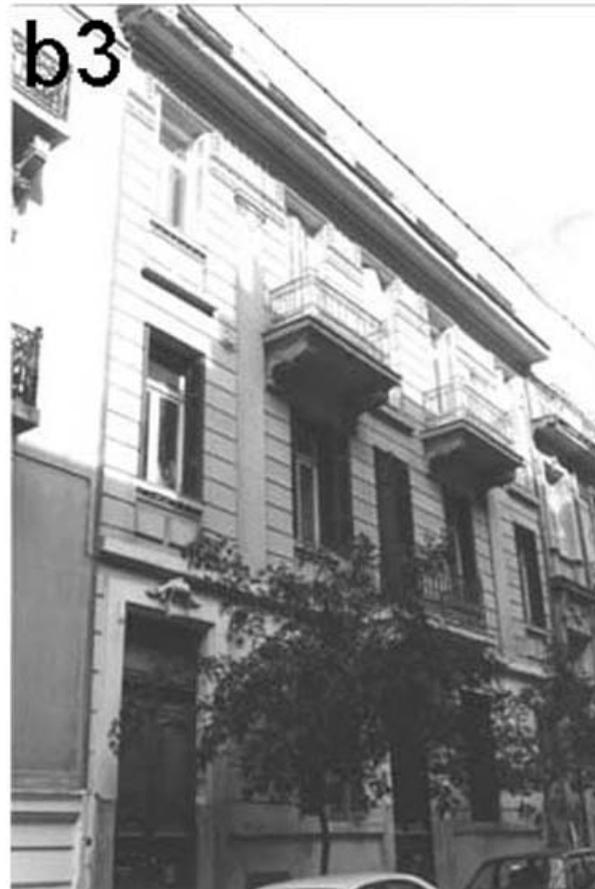
Figure 1. The six small format images used in the test

The approach has been tested with several images taken for this specific purpose. However, to assess its performance in a more realistic way it was decided to avoid 'convenient' photographs. Thus, images of two building were selected which had been taken in the context of students' projects regarding planar facades. In these photographs a few short lines (balconies) in depth also 'happened' to be present, providing a third vanishing point.

All six images, shown in Fig. 1, had been taken on three different occasions with small format camera and 35 mm

lenses. Certain object dimensions were known to allow for checks. The results seen in Tables 1 and 2 refer to enlarged paper prints not including the full negative format. The metric information derived from these uncalibrated photographs is regarded as indeed satisfactory, with differences of just a few cm in depth and differential scales in height maximally reaching 1.4% (10 cm in 7 m). Furthermore, the presented results might well be considered as somehow representative since they include cases with relatively small and very large rotations (images a and b, respectively), as well as differences regarding lines: clear but badly distributed in depth (images b); well distributed though short and unclear (images a).
